United States
Department of
Agriculture

Marketing
Research Report
Number 1126

Evaluation of a Shell Egg-Packing Plant Layout

J.W. Goble¹, Charles Goulston², John Bouma², and James L. Heath³

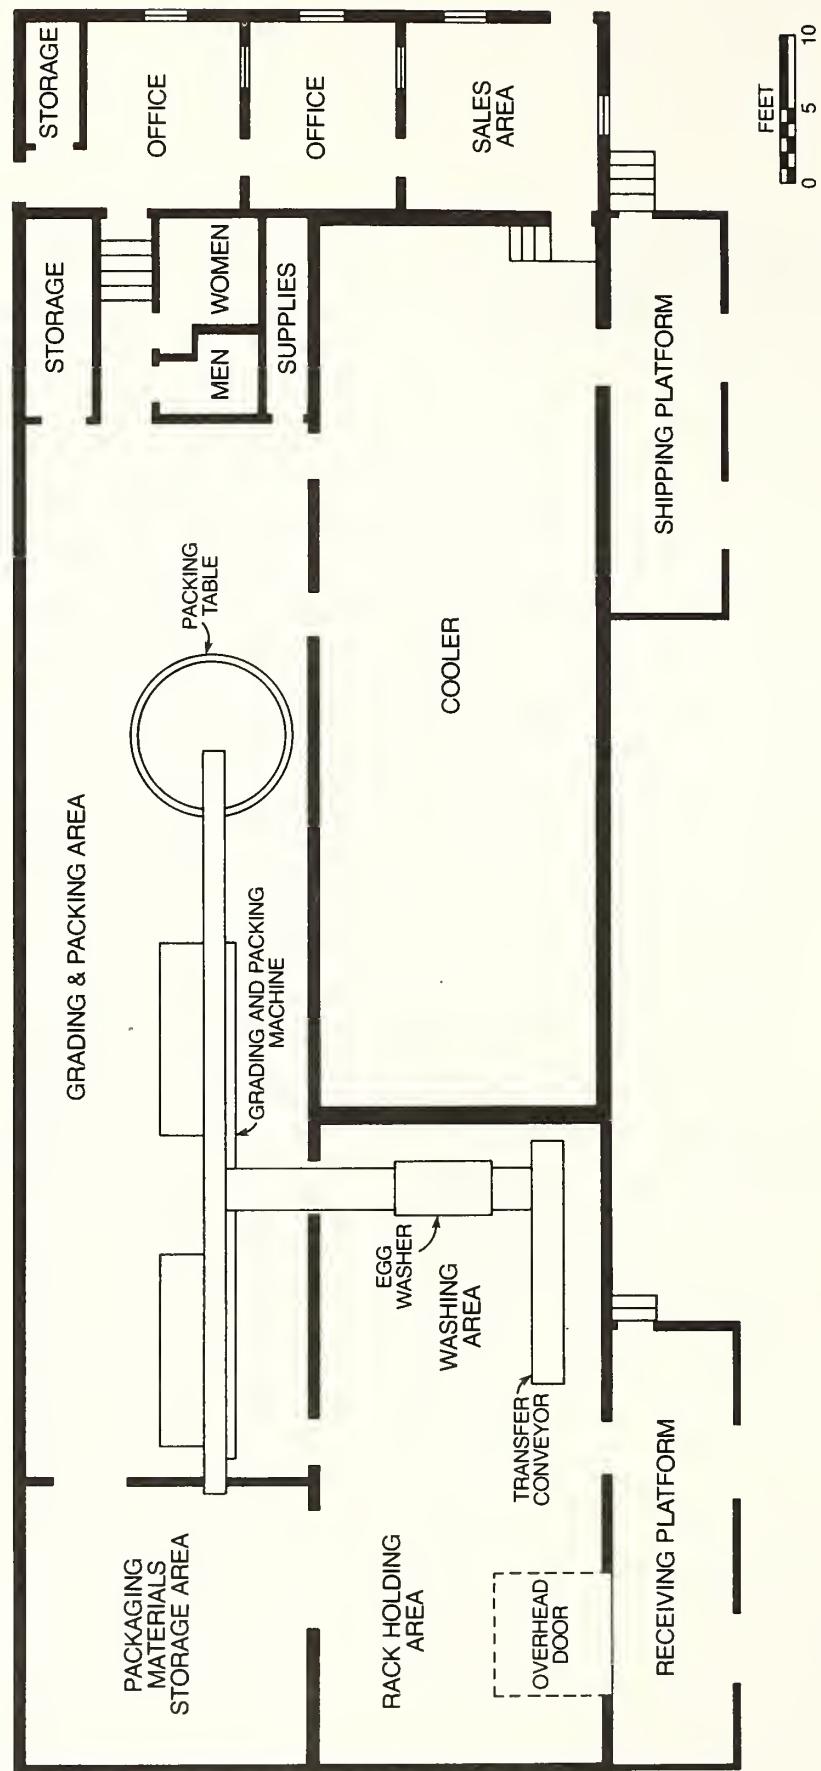
Figure 1.—Layout of the old plant.

The building was not constructed originally for use as a shell egg-packing facility but was converted to that use sometime later. A partition divided the operational section of the building lengthwise into two primary areas each 19 feet wide (fig. 1). The egg-washing operations occupied one section and egg-grading and packaging operations the other. Storage areas consisted of a room for packaging materials and a small cooler for packed eggs ready to be shipped.

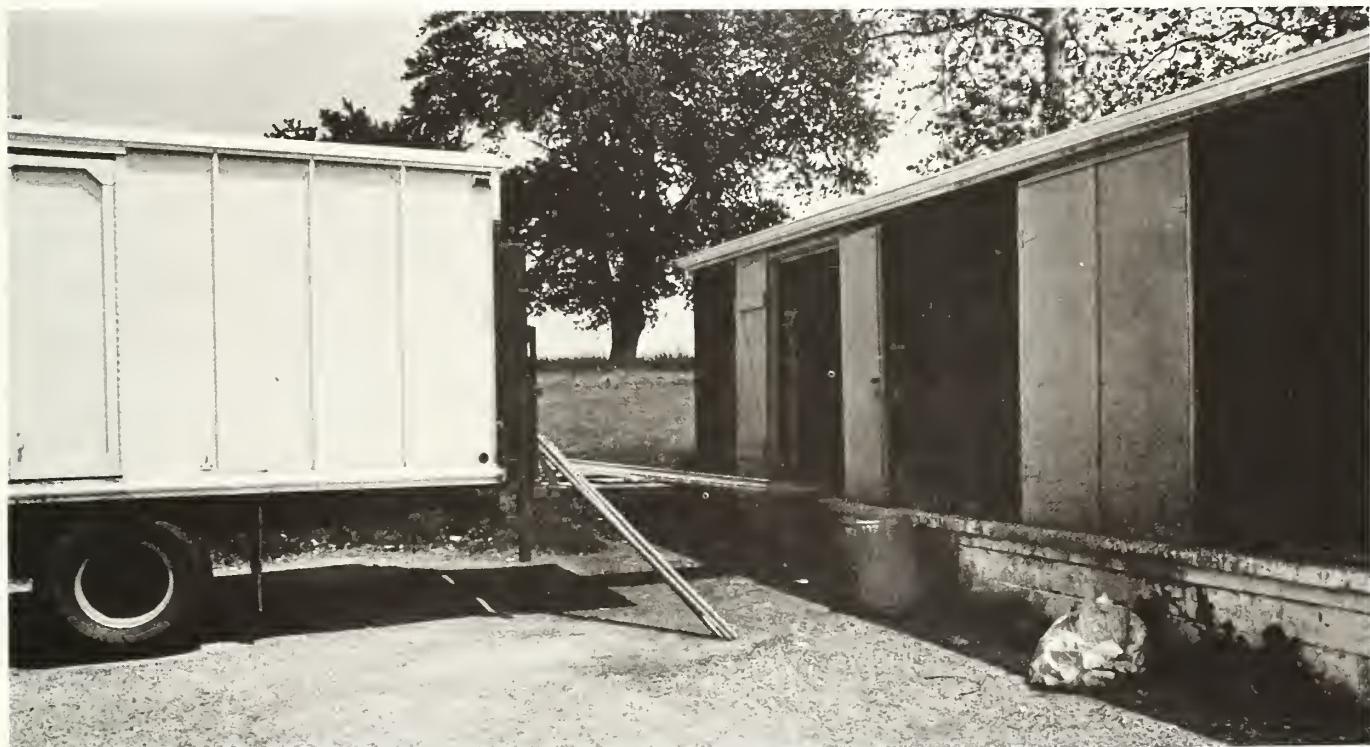
Figure 2.—A portable ramp used for receiving and shipping eggs in the old plant.

Another hazard was the receiving operation that necessitated using a narrow ramp for unloading trucks.

Racks of eggs moving down the ramp endangered a person attempting to control the speed of descent by standing in front of the rack.

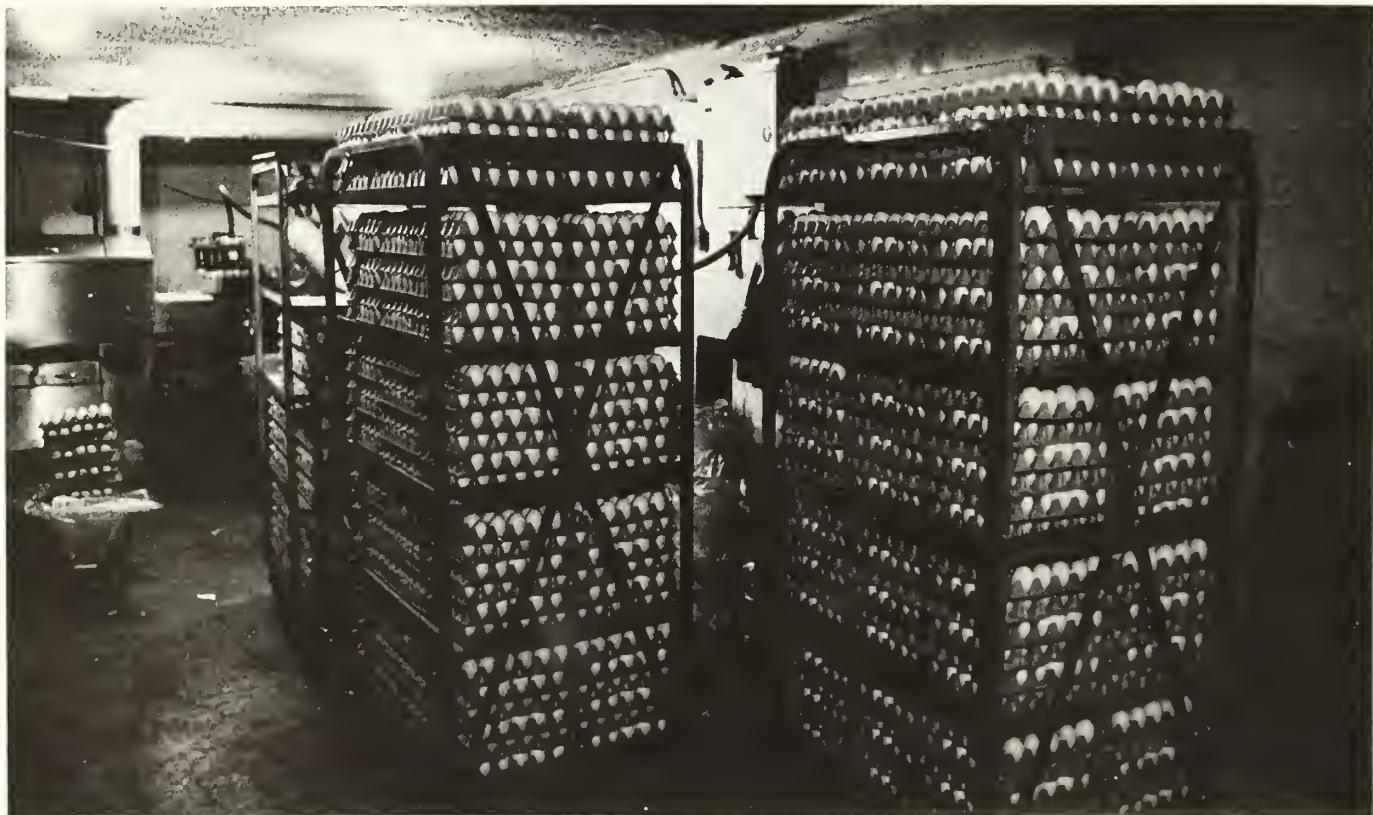
Racks of eggs were unloaded from trucks and held in a portion of the washing area (fig. 3). When the area was full, remaining racks of eggs had to be held near the washing operation where the temperature was much higher than the prescribed 60° F maximum for holding incoming eggs. The racks of eggs created congestion in the washing area, as did empty racks that were waiting to be returned to the farms. Since no rack storage area was available, empty racks were intermingled with the full ones. Because of inadequate floorspace, the egg-packing equipment was positioned too near the

Figure 3.—Racks for receiving incoming eggs.

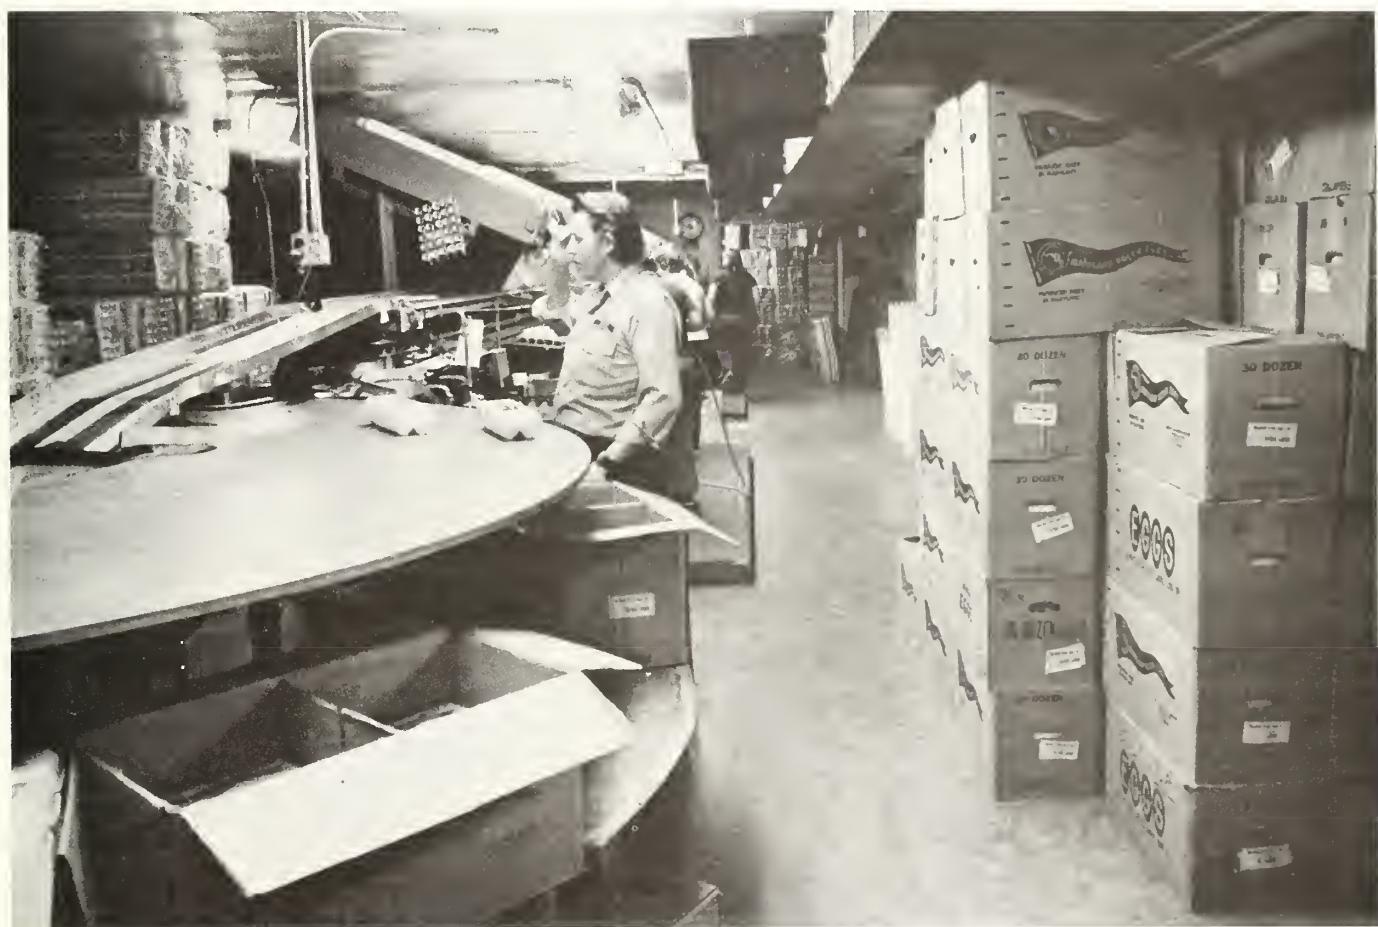
Egg cases had to be formed and stored temporarily in the carton-casing area. Although the cases were convenient to the casing operation, they added to the congestion of the area (fig. 4). At times the passageway was completely obstructed by empty cases.

Figure 4.—The congested casing area.

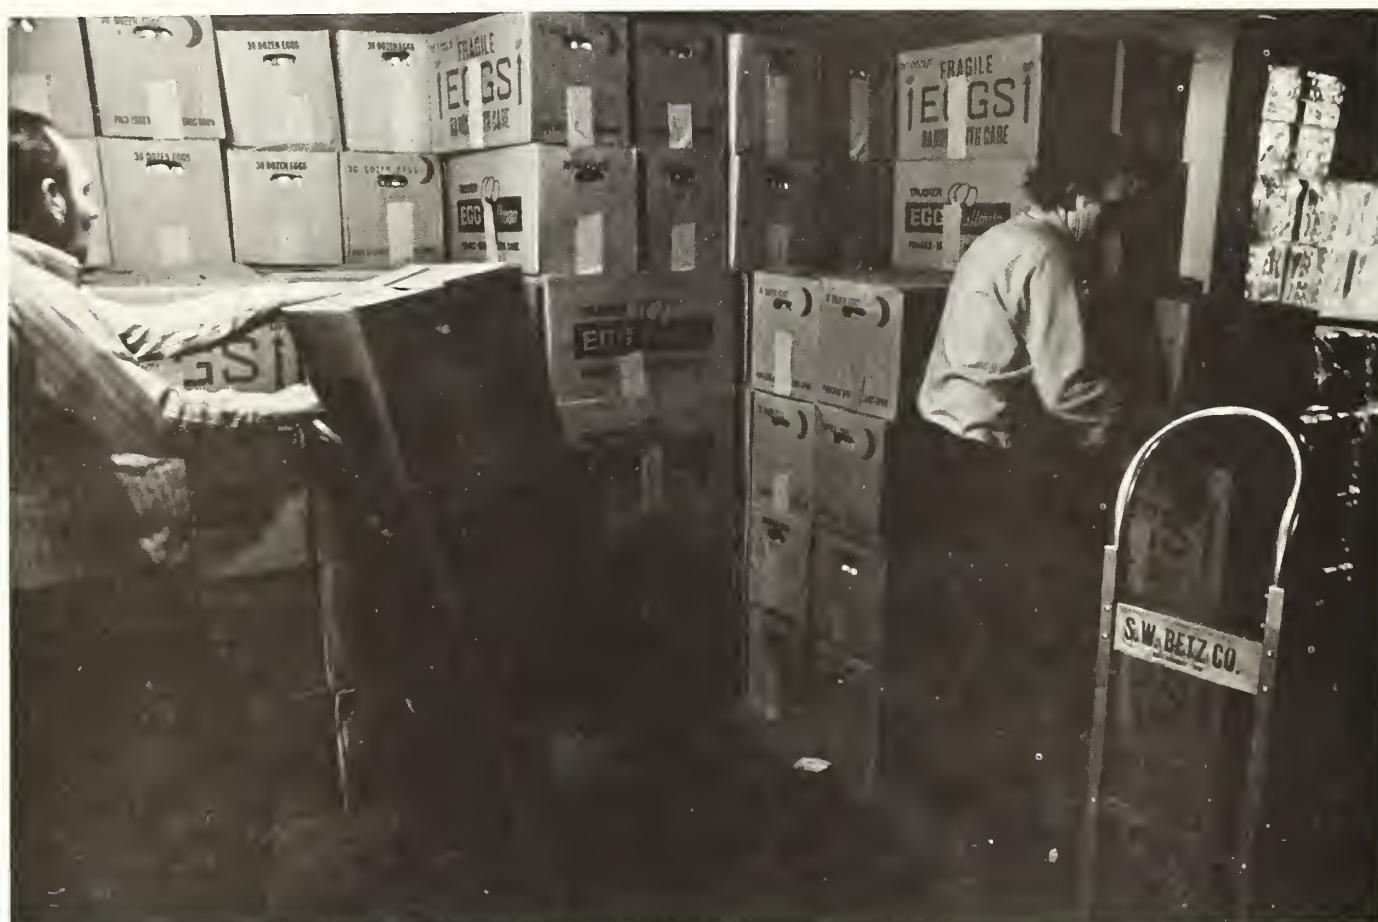
The cooler for eggs that had been sized, graded, and packed was inadequate (fig. 5). When the cooler was full, all remaining eggs had to be held temporarily in the packing area, which added to the congestion. More importantly, eggs not placed in the cooler were subject to loss of quality after the grade had been established and the product labeled. Lack of cooler capacity also made it difficult to rotate inventory, which could adversely affect quality.

Figure 5.—Cased eggs being moved into cooler.
